# Manhole Inspection Summary

## Manhole # S39E2\_017MH

Insp Date: **4/1/08 11:39 AM**

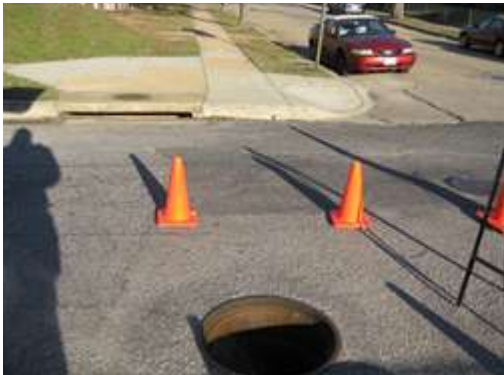
Location View

Townsend & 5th St

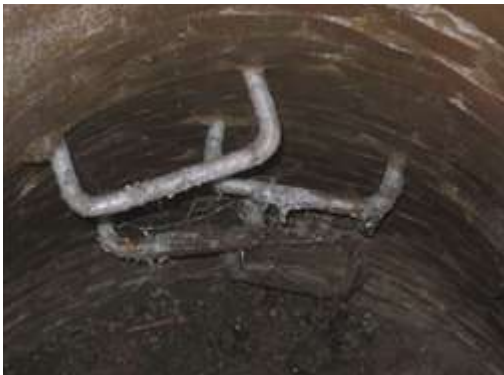
**Steps** Count: **4** Missing: **0** ☒ **Corroded**

steps

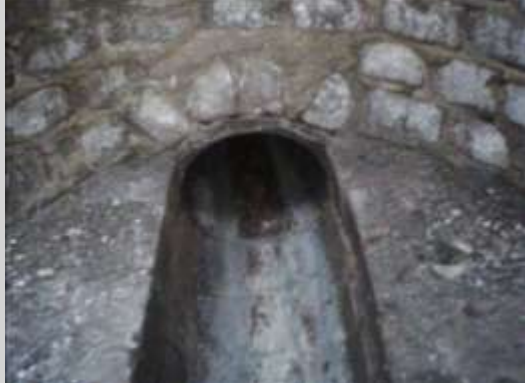
12 O'Clock Outflow

8 in. Circular Gravity Sewer  
Pipe Out @ 12 O'Clock

Pipe Height: **8.4** (in.) Rod and Bar (Angled)  
Pipe Material: **Clay** ☐ Pipe Lined  
Invert Depth: **7.56** (ft.) Flow Characteristics: **Fast**  
Deposits: ☒ None ☐ Mud ☐ Sludge ☐ Debris ☐ Grease  
Silt Depth: (in.) Deposits Extent:  
Infiltration: **None** Pipe Seal Cond: **Sound**

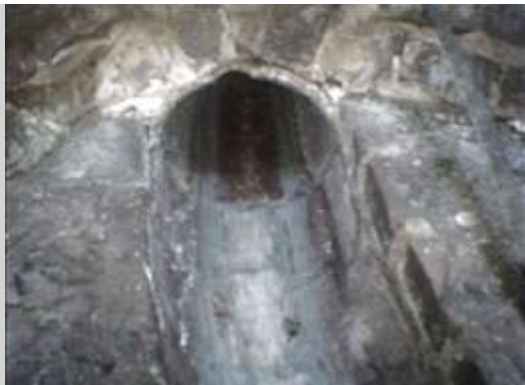
6 O'Clock Inflow

8 in. Circular Gravity Sewer  
Pipe In @ 6 O'Clock

Pipe Height: **8.4** (in.) Rod and Bar (Angled)  
Pipe Material: **Clay** ☐ Pipe Lined  
Invert Depth: **7.62** (ft.) Flow Characteristics: **Fast**  
Deposits: ☒ None ☐ Mud ☐ Sludge ☐ Debris ☐ Grease  
Silt Depth: (in.) Deposits Extent:  
Infiltration: **None** Pipe Seal Cond: **Cracked**
